TIRE DAMPER

A thesis submitted to the faculty of
The University of Utah
in partial fulfillment of the requirements for the degree of

Master of Science

Department of Civil and Environmental Engineering

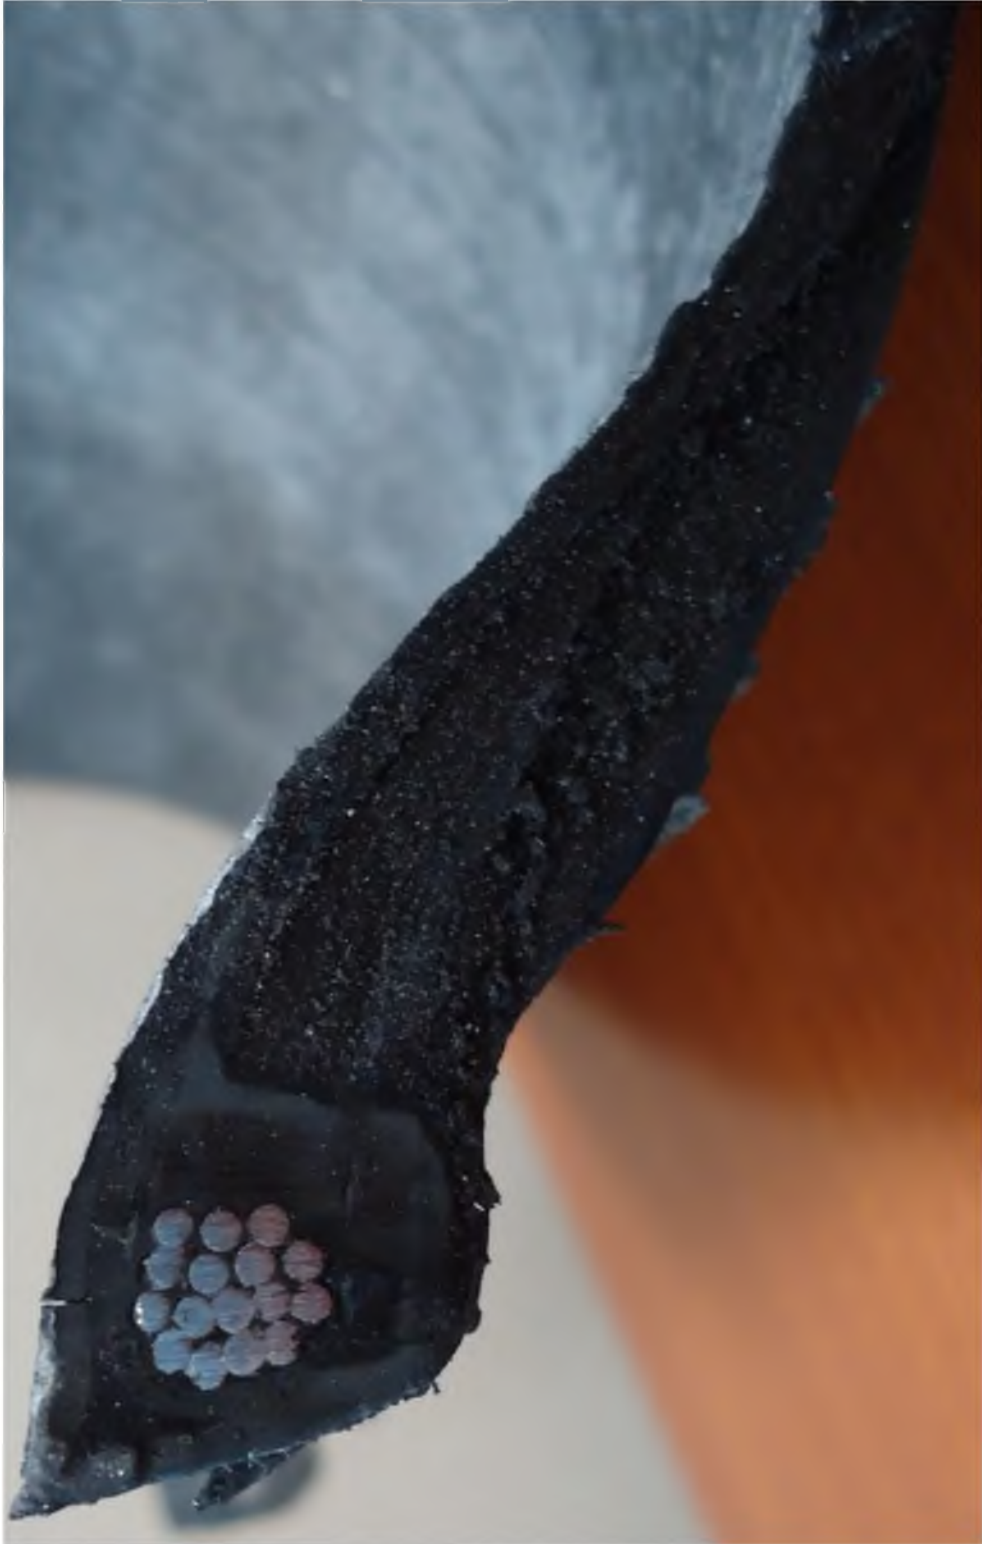
Figure 1 - Tire Bead

In designing this damper, tire dissection became important. The dissection allowed for the tire to be dismembered and inspected. This allowed for a better understanding of the damper failure. The different portions of the tire which the reader is most likely not familiar with are discussed and pictured below. First is the bead of the tire which consists of 16 metal wires. These wires wrap around the inner diameter of the tire to give it added strength and keep it together. This can be seen in **Figure 1**.

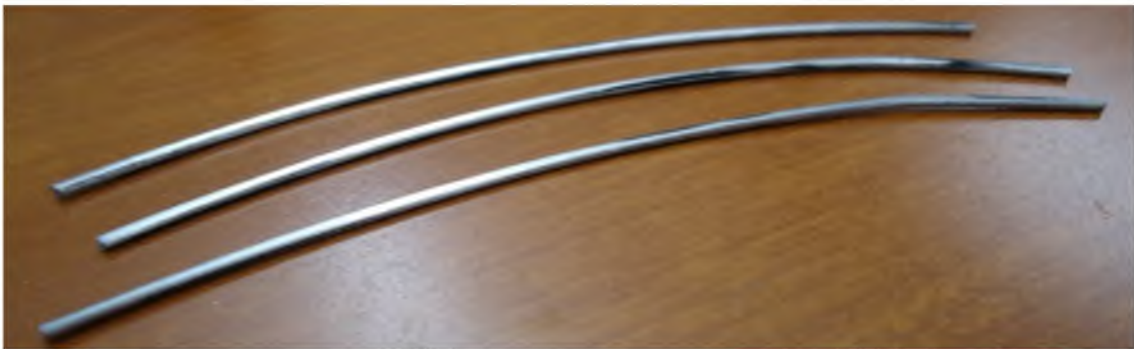
Figure 3 - Steel Belts Perpendicular View

Figure 3 shows a 90 degree view of the perpendicular wire meshing, which is known as the steel belts. This picture shows very well how the steel belts are woven together.

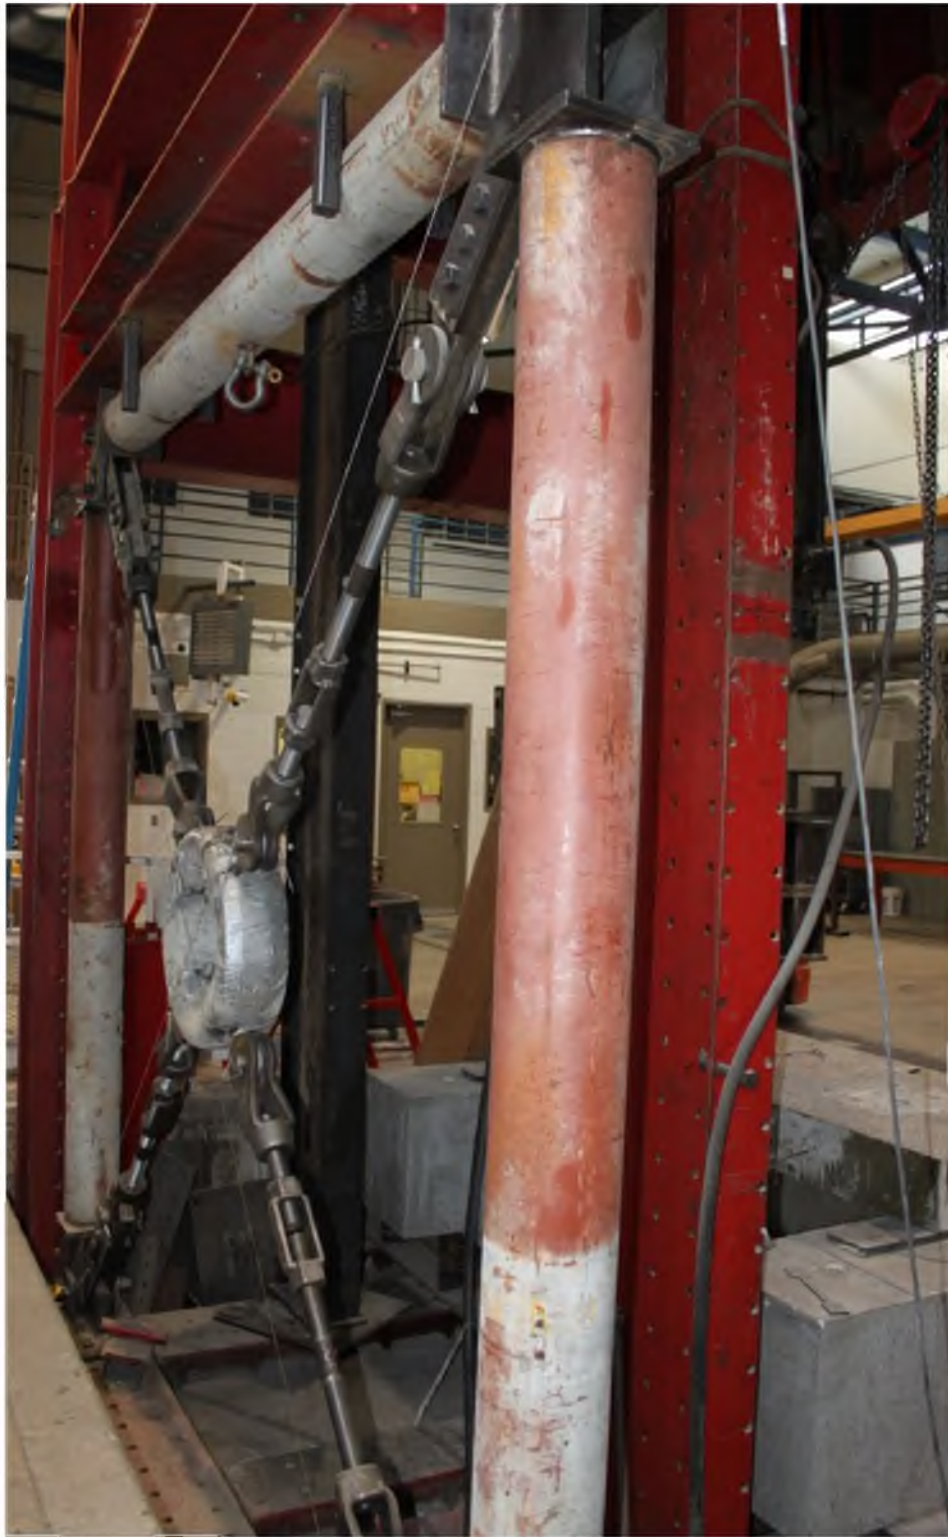
Figure 8 – Test Frame

A full scale sway frame was constructed for this research. In this frame, lateral movement is induced in the structural system by the horizontal actuator which is installed parallel to the top frame member. An actuator is a hydraulic fluid motor which simulates the displacement cycles. This lateral displacement creates alternating tension forces which act on the damper. The lateral displacement can reach up to 7 inches in each direction. This is a great deal of displacement in a building; ideally the deformation would be much smaller than this in a real life building. The picture in **Figure 8** was taken after the installation of the damper and before the commencement of the testing.

The tire was stretched in two directions with controlled displacement using the cyclic testing frame shown in **Figure 8**. Values started at 0.2 inches of displacement and continued in increments of 0.2 inches until failure was reached. The displacement was achieved with the use of a hydraulic ram. This equipment was designed to directly output displacement and force values in relation to time into a computer spreadsheet. The information from the spreadsheet was utilized to create the hysteresis loops in this section and graphs shown in **section 5** of this report.

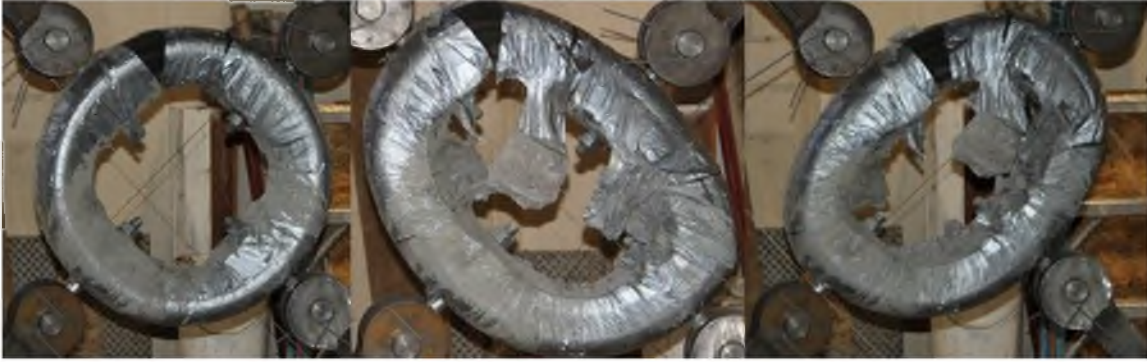
Figure 13 - Test One Maximum Elongation

A great deal of energy is dissipated as the concrete begins to crush, spall, and crack in these maximum elongations. The duct tape on the damper helps to prolong the strength of the damper by holding the fractured concrete in the tire. As the deformation increases the duct tape tears and no longer helps the concrete to retain its strength. The failure of the concrete is shown at two different stages in **Figure 17**, where the concrete has crumbled and fallen and the reinforcement bar is exposed. Note that this picture was taken after the duct tape was removed from the area.

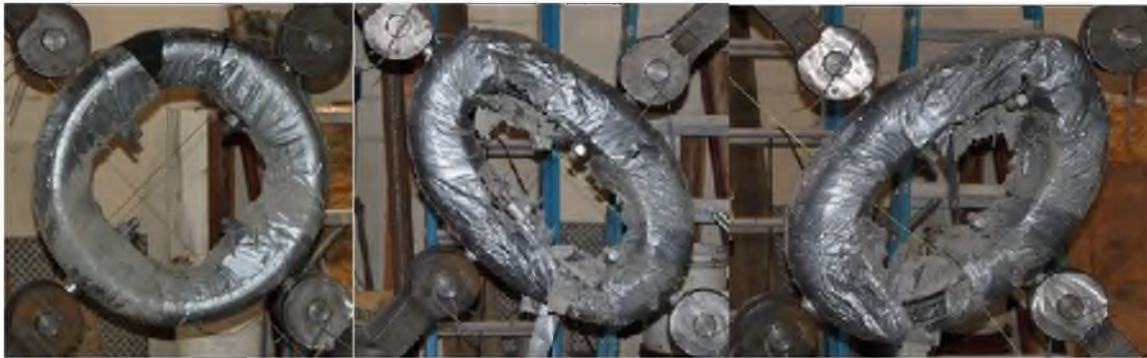
A depiction of the maximum elongation can be seen in **Figures 13, 14, 15, and 16** for each of the four tests.

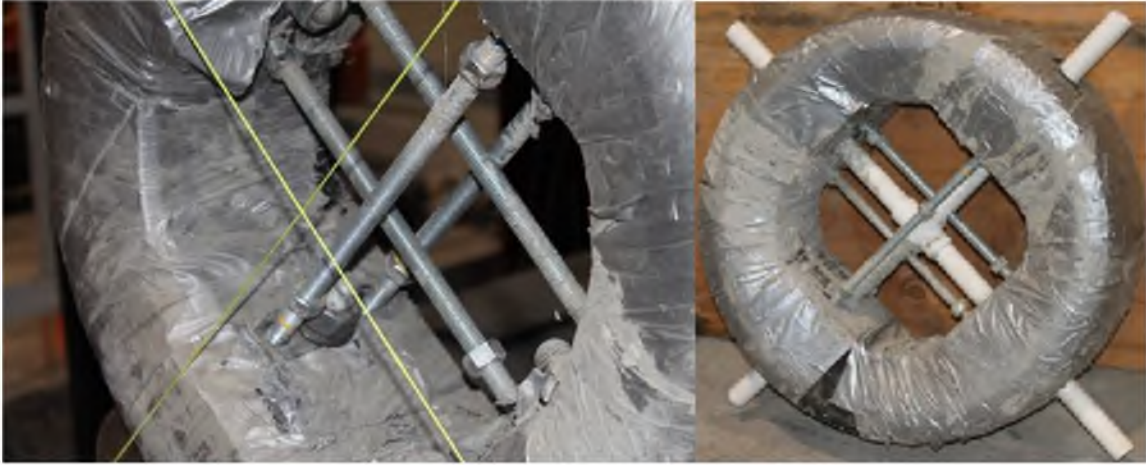
Figure 19 – Tests Three and Four Rods

Two of the four tests also included rods, as shown in **Figure 19**. When these rods fail, a very loud noise is heard as the metal elongates and buckles. The progressive failure of the rods can be seen in the collage in **Figure 20**.

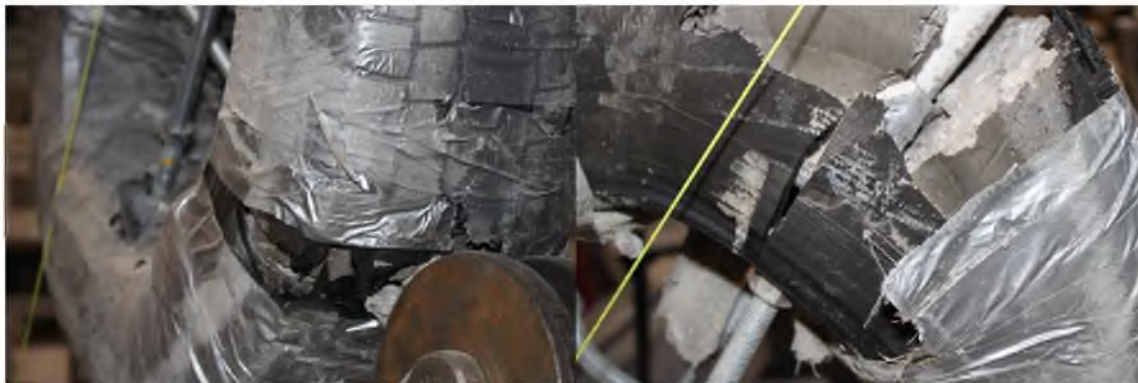
Figure 22 – Rubber and Steel Belt Failure

Once the rod fails the rubber begins to tear, especially around the four I-bolt connections which secure the tire to the frame in tension. The failure of the rubber and steel belts within the rubber can be seen in the pictures shown in **Figure 22**.

Through the different tests, it was noted that the tire rubber tended to rupture at the pin connection. This is because a hole was cut in the tire for I bolt. It is possible that the tire could be reinforced around the I-bolt hole to improve the strength of the damper.

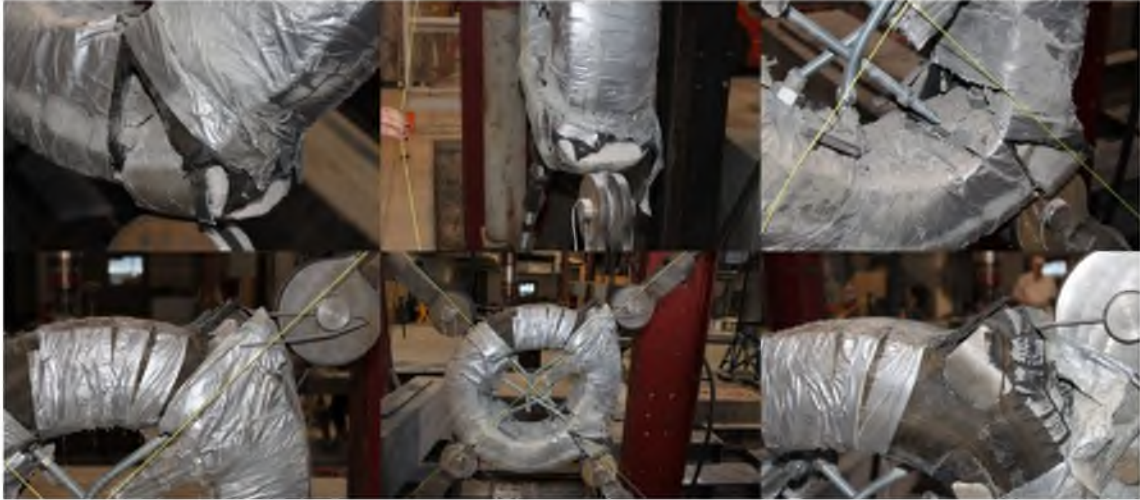
Figure 23 – Wedge Failure in Test Three

As the deformation of the reinforcement bar, rubber from the tire, and the steel belts within the tire continues, an increasingly high amount of energy is dissipated. Failure was achieved when the loading capacity of the damper began to sharply decrease due to the fatigue of the system. The plates at these connections caused tapered wedge failure at the four connections. This failure is shown in **Figure 23**.

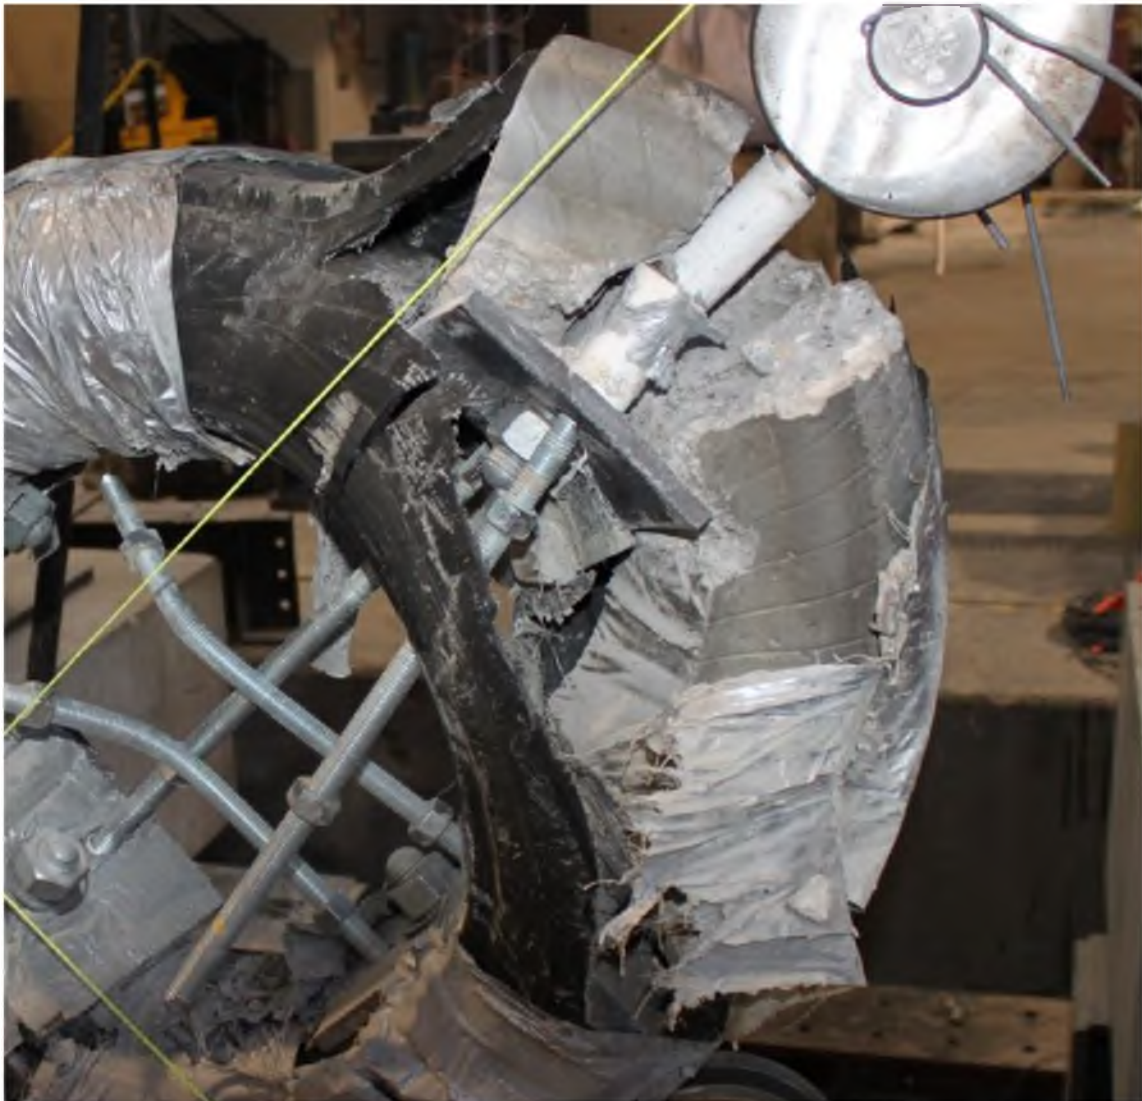
Figure 24 – Wedge Failure in Test Four

In the second rod test the ultimate failure was even more pronounced, as seen in **Figure 24**. This failure occurred when the deformations were beyond 5 inches. Note that the duct tape was again removed from the tire in the affected areas before this picture was taken.
